EXPLOSIVE SIZING OF 70-INCH DIAMETER WELDED
ALUMINUM PREFORMS FROM 5086, 2014 T4 AND
2014 T6 MATERIAL

NATIONAL AERONAUTICS and SPACE ADMINISTRATION
GEORGE C. MARSHALL SPACE FLIGHT CENTER
HUNTSVILLE, ALABAMA

Report No. 62B057
16 April 1962

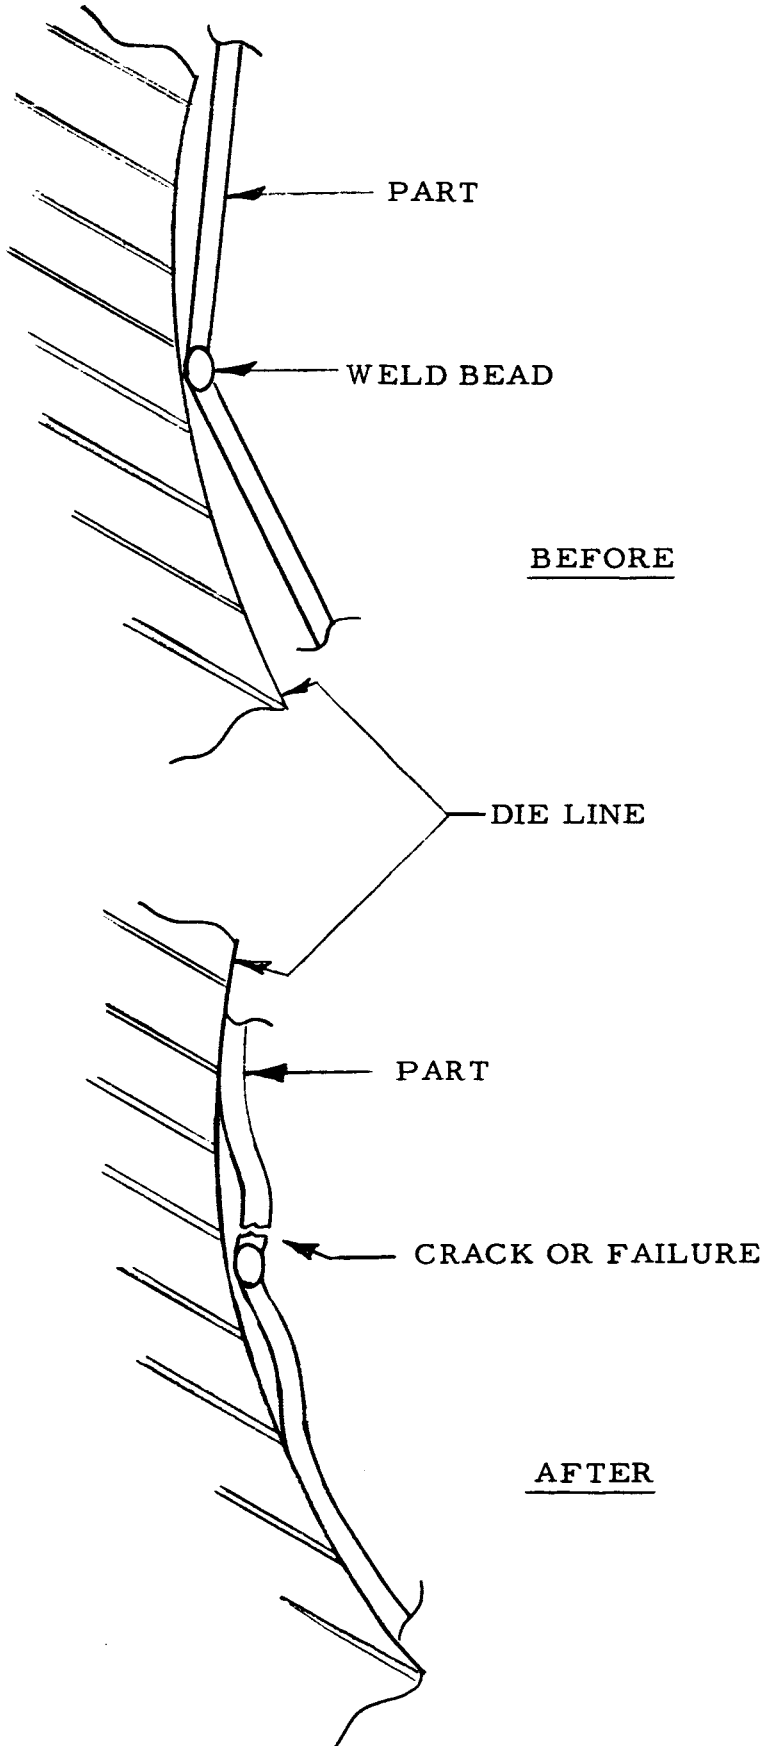
Figure I Cross Section Showing Roof-type Circumferential Configuration and Forming Results

From past explosive sizing experience, it has been established that a portion of the failures can be attributed to the configuration of the cones at the circumferential mating edges. Successful sizing results on the .090" thick, 5086 bulkheads, have proved that pre-rolling of the circumferential mating edges to a 12 T radius prior to welding eliminates a "roof" type configuration. (See Figures I and II). This allows a minimum of forming to take place in the weld area.)

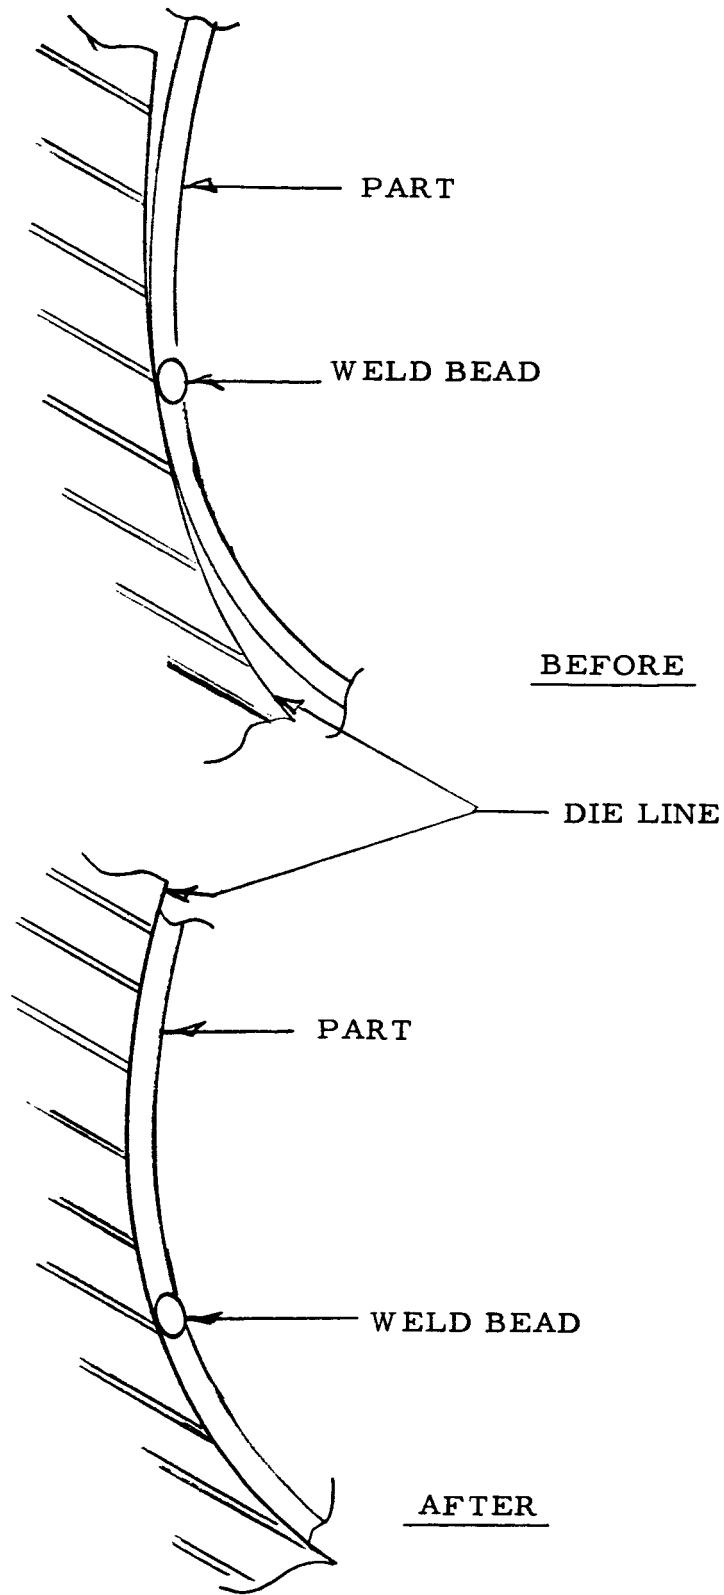
Figure II Cross Section Showing the Preferred Rolled Circumferential Mating Edge Configuration and Forming Results

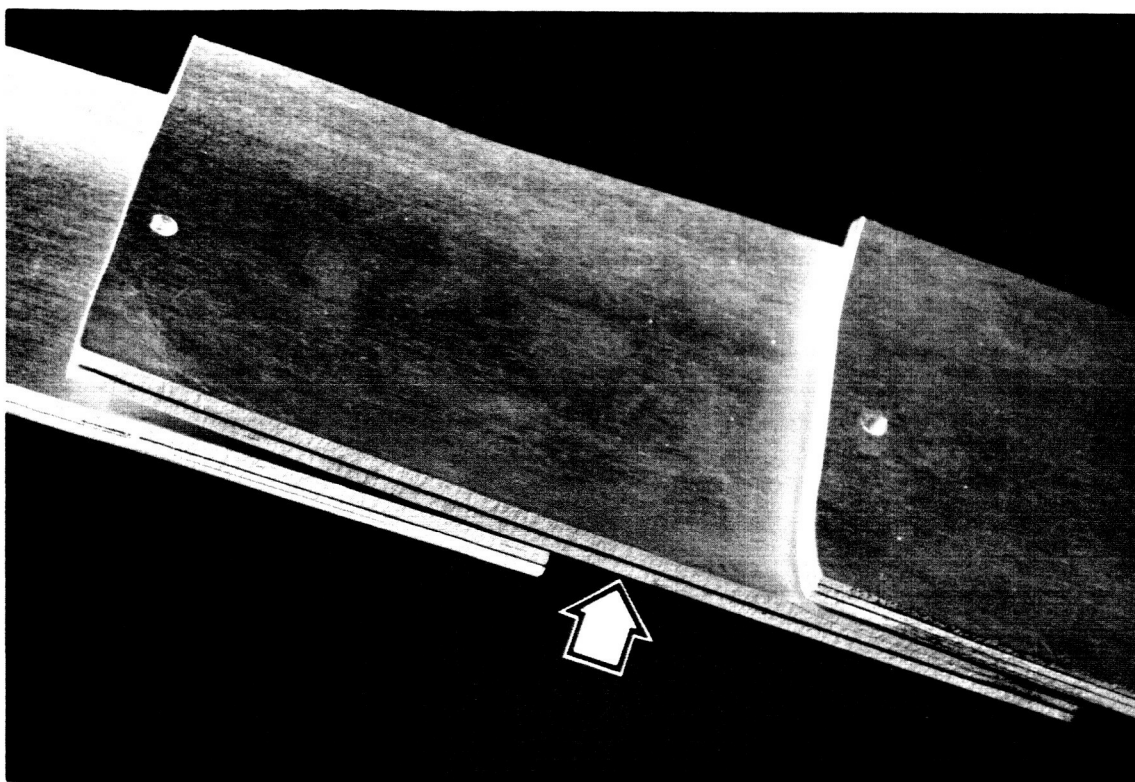
During this period of performance no additional work was done on these bulkheads. A test was run though on a sample piece of 2014-T6 to determine whether or not the T6 material would withstand the edge rolling required. The specimen was .250" thick, by 3" wide, by 3 feet long. After rolling, shear failure occurred in both edges of the specimen. Existing rolls with 1-1/4" radius were used (See Figures III and IV) showing shear failure.

Figure III Edge Rolled Specimen - Sheared Edge Showing Material Separation
As Shear Failure on .250" Thick, 2014 T6 as a Result of Edge
Rolling to 1-1/4" Radius

1. Fabricate new rolls with a 12T or 3" radius for circumferential edge rolling.
2. Re-develop the cones to accept the 12T radius.
3. Re-design and fabricate new trim and welding tooling to accept 12T radius.

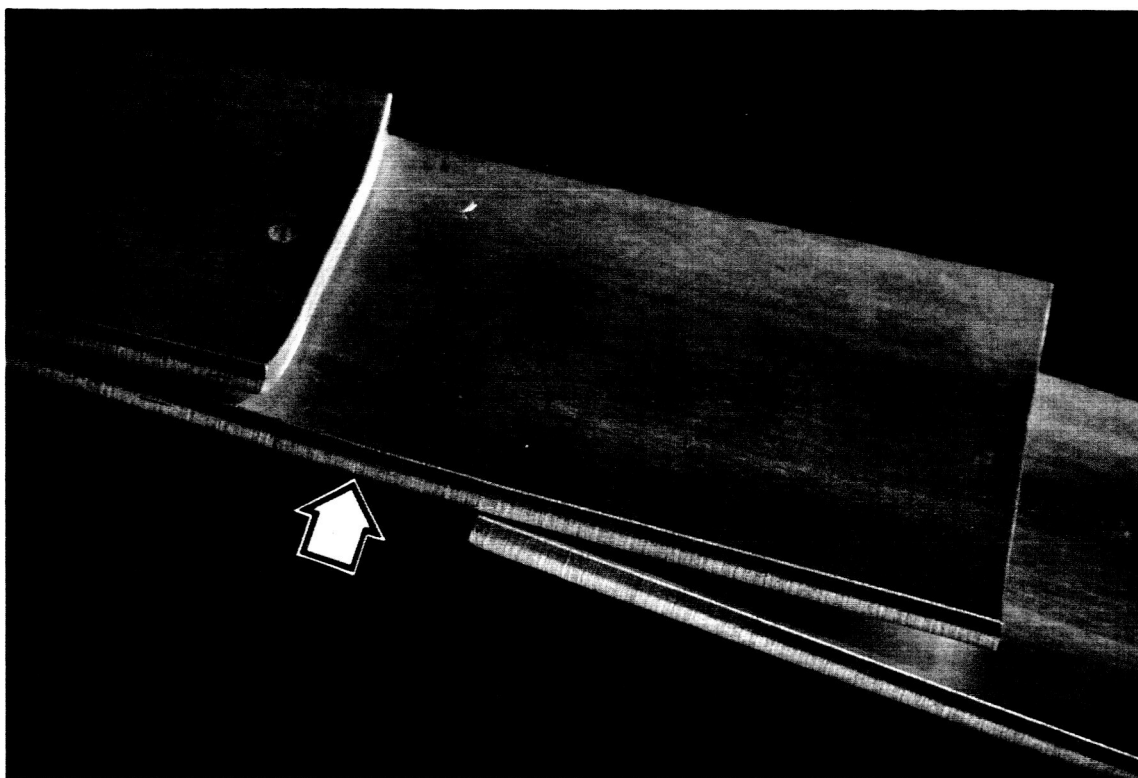
Figure IV Edge Rolled Specimen - Sawed Edge Showing Crease and Localized Separations on .250" Thick, 2014 T6 as a Result of Edge Rolling To 1-1/4" Radius

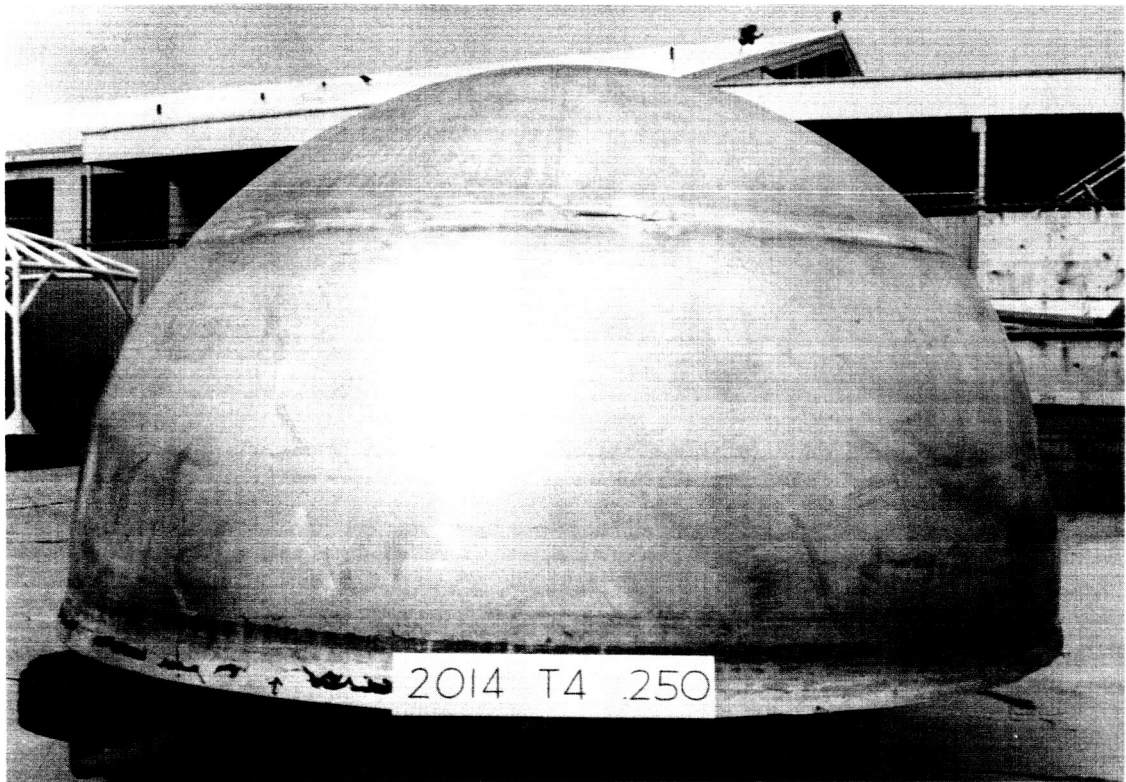
Figure V Bulkhead No. 1 - Showing Circumferential Failure and Position of Sound Longitudinal Weld. Approximately 85% Formed.

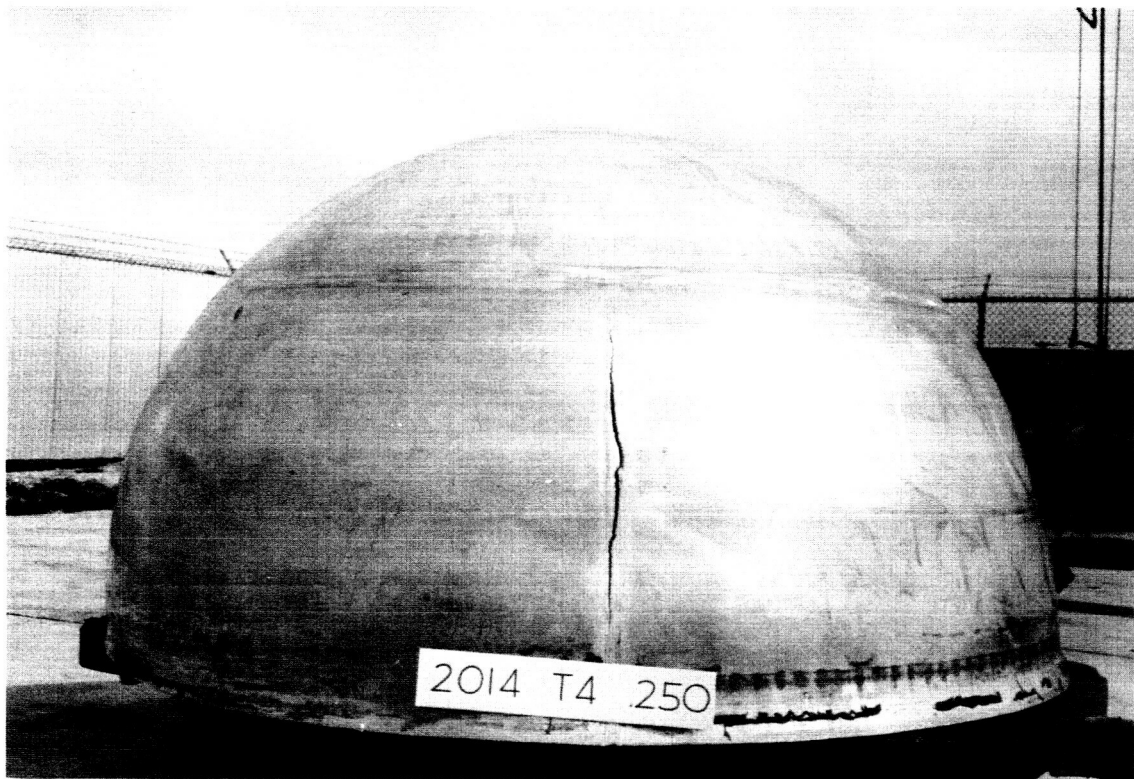
Figure VI Bulkhead No. 1 (Rotated 90°) - Showing Longitudinal Weld Failure. Not Visible are Intermittent Longitudinal Cracks Throughout Circumferential Weld.

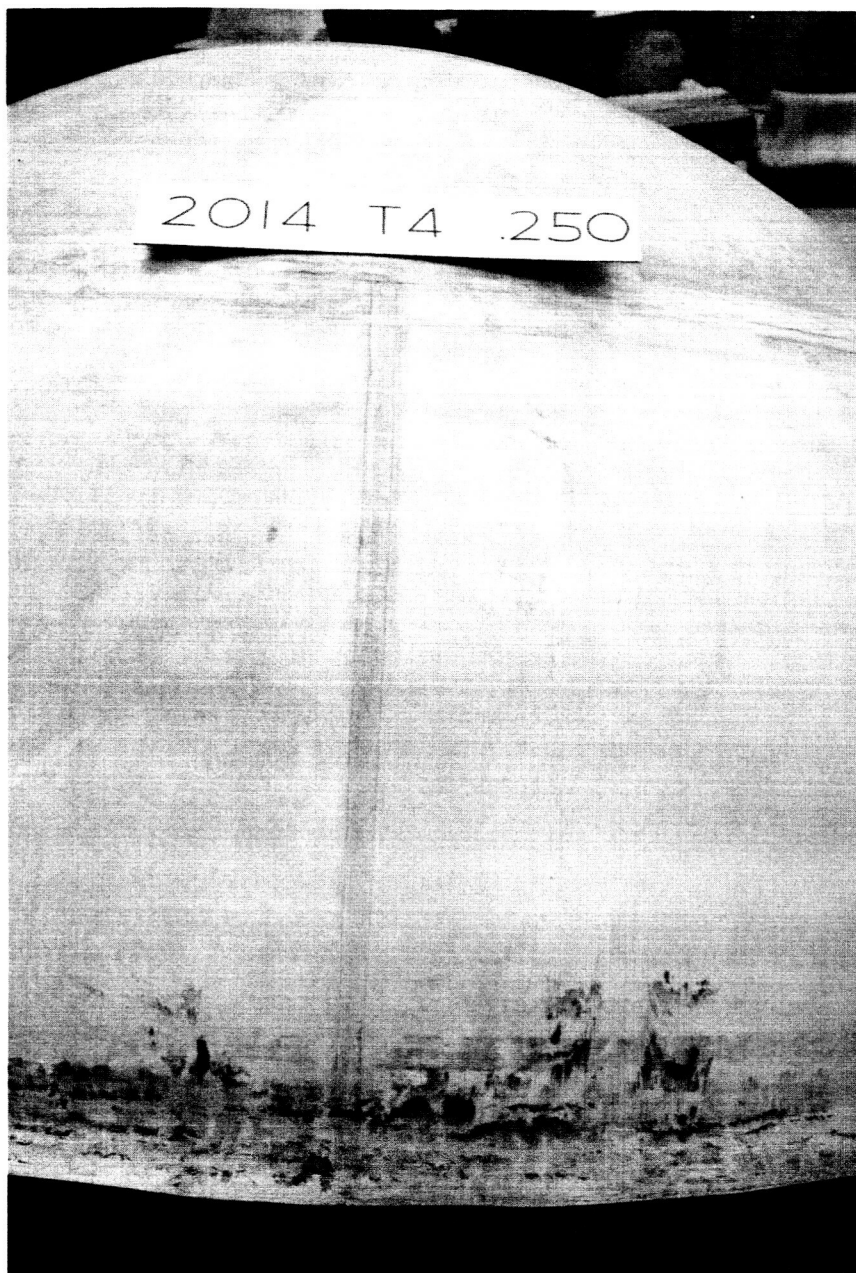
Figure VII Bulkhead No. 1 - Opposite Side of Figure VI, Showing Sound Longitudinal Weld

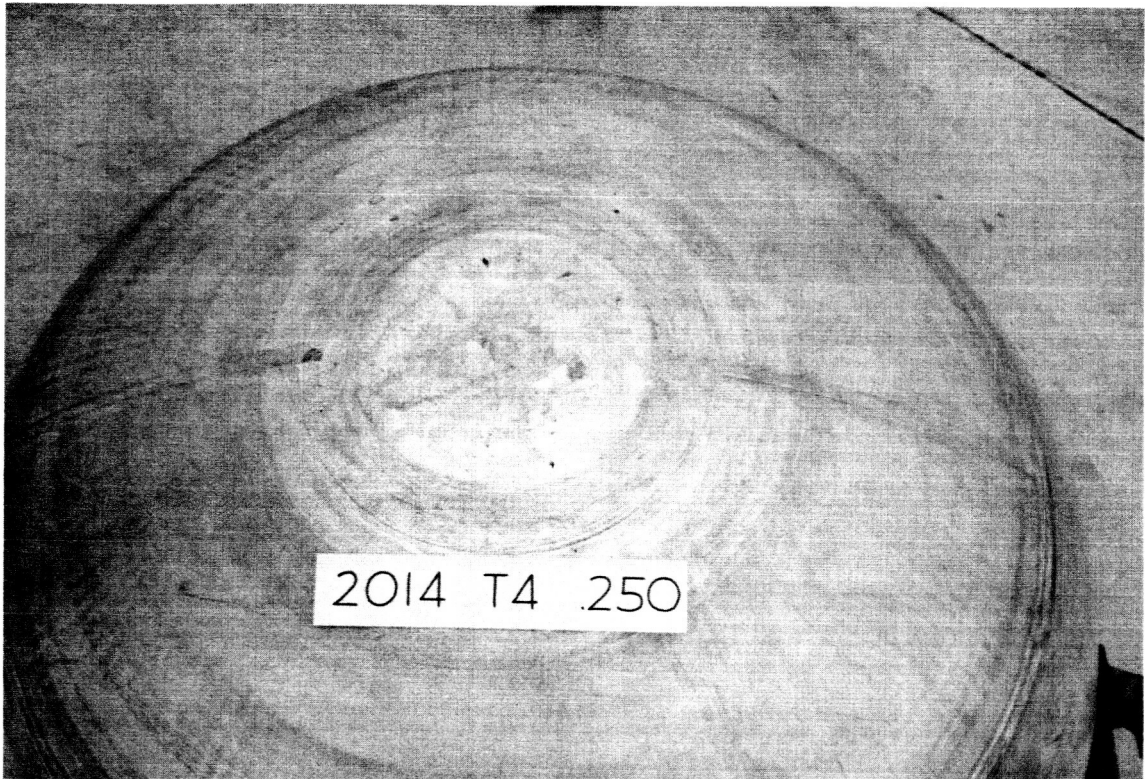
Figure VIII Bulkhead No. 1 - Top View Showing Sound Longitudinal and Circumferential Welds

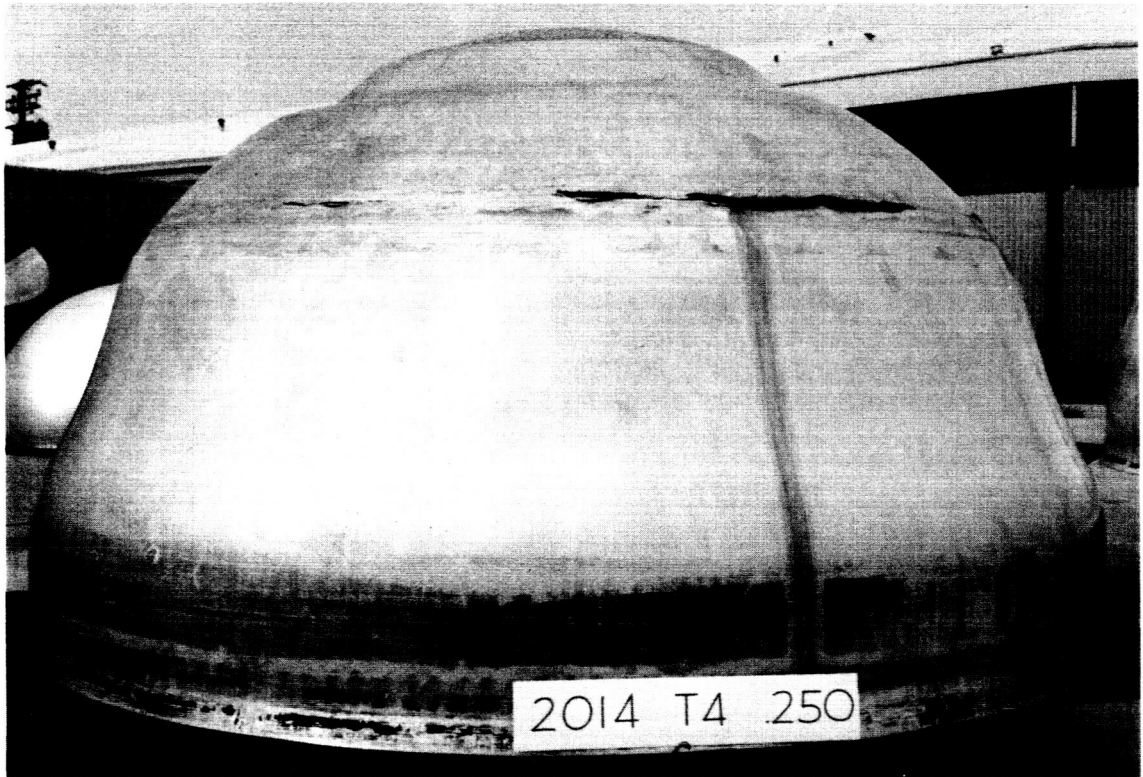
During this period of performance an attempt was made to explosively size bulkhead Number 2. The bulkhead fractured in the circumferential and longitudinal weld areas.

Figure IX Bulkhead No. 2 - Showing Circumferential Failure and Sound Longitudinal Weld. Approximately 65% Formed.

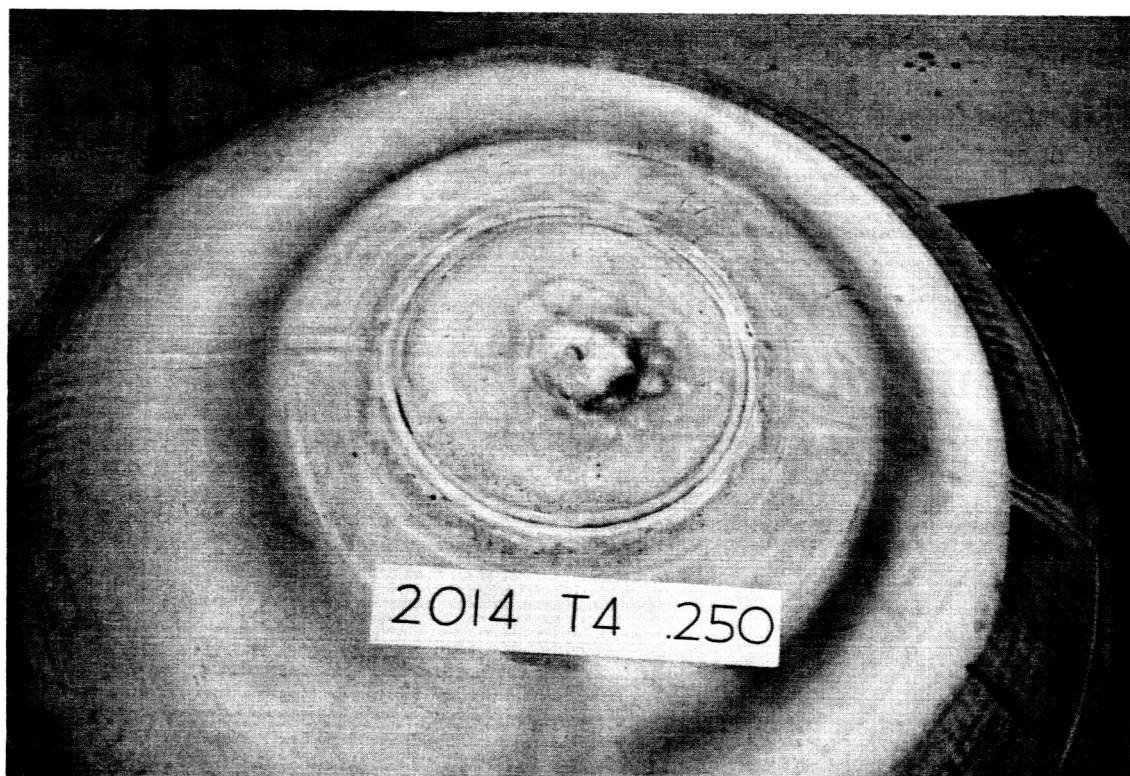
Figure X Bulkhead No. 2 - Top View Showing Sound Longitudinal and Circumferential Welds
